# Manhole Inspection Summary

Manhole # S29II2008MH

Insp Date: **3/28/07 9:48 AM**

**Location** Address: **6003 CHARLES ST**

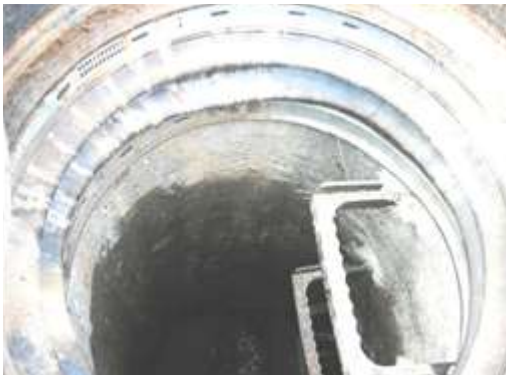
Defect

Infiltration: ☐ None ☐ Joint ☐ Cracks ☐ Mortar ☐ Roots ☒ **Wall**

Adjustment and Corbel infiltration - other side.

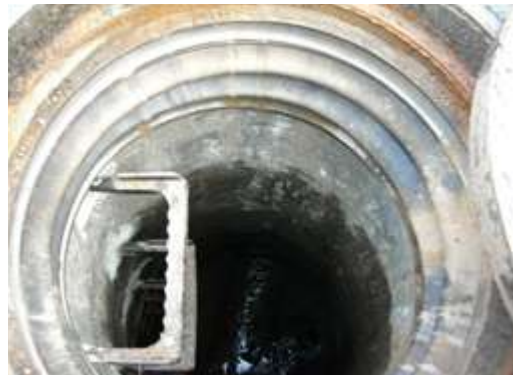
Defect

☒ **Leaks**

Adjustment and Corbel infiltration.

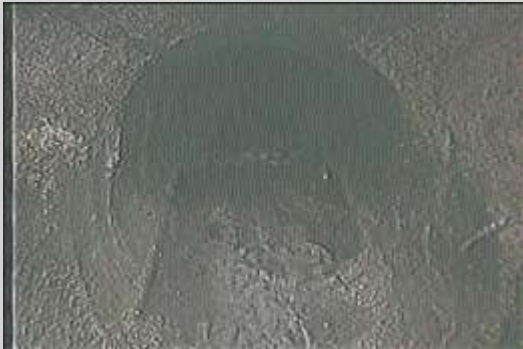
### 12 in. Circular Gravity Sewer Pipe Out @ 12 O'Clock

Deposits: ☐ None ☒ **Mud** ☐ Sludge ☒ **Debris** ☐ Grease

Silt Depth: **0.5** (in.) Deposits Extent: **Light**

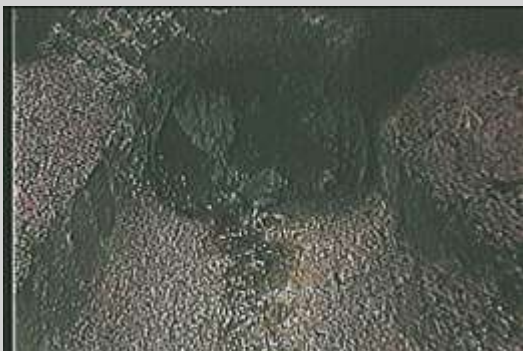
### 10 in. Circular Gravity Sewer Pipe In @ 6 O'Clock

Deposits: ☐ None ☒ **Mud** ☐ Sludge ☒ **Debris** ☐ Grease

Silt Depth: **1** (in.) Deposits Extent: **Light**

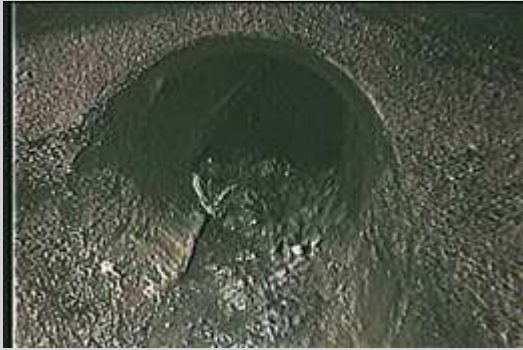
Pipe In @ 8 O'Clock

Deposits: ☐ None ☒ **Mud** ☐ Sludge ☒ **Debris** ☐ Grease

Silt Depth: **0.5** (in.)
